# The Alpha and the Omega

## A Study of Two Japanese Type 99 Short Rifles

By Ralph E. Cobb

First Published January 20, 2012 on Surplus Rifle Forum Wiki and Knowledgebase

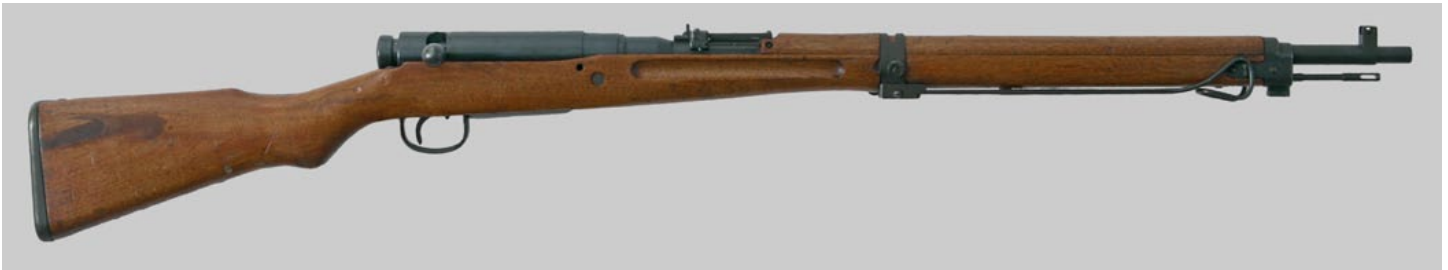
The original Type 99 example used in this study is from the 3rd Series produced at the Nagoya Army Arsenal, in approximately November–December 1941. This rifle represents the high-water mark of Japanese military success.

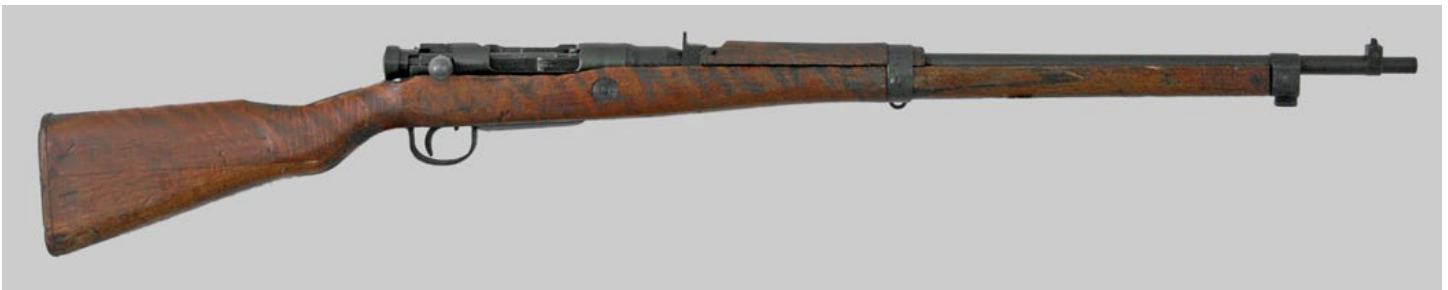
The Substitute-Standard Type 99 example presented is from the 25th Series produced at the Kokura Army Arsenal, in early 1945. It was one of the last 25,000 Type 99 Short Rifles made at Kokura Army Arsenal and illustrates the desperate circumstances in which the Japanese found themselves as the Allies closed in on Japan.

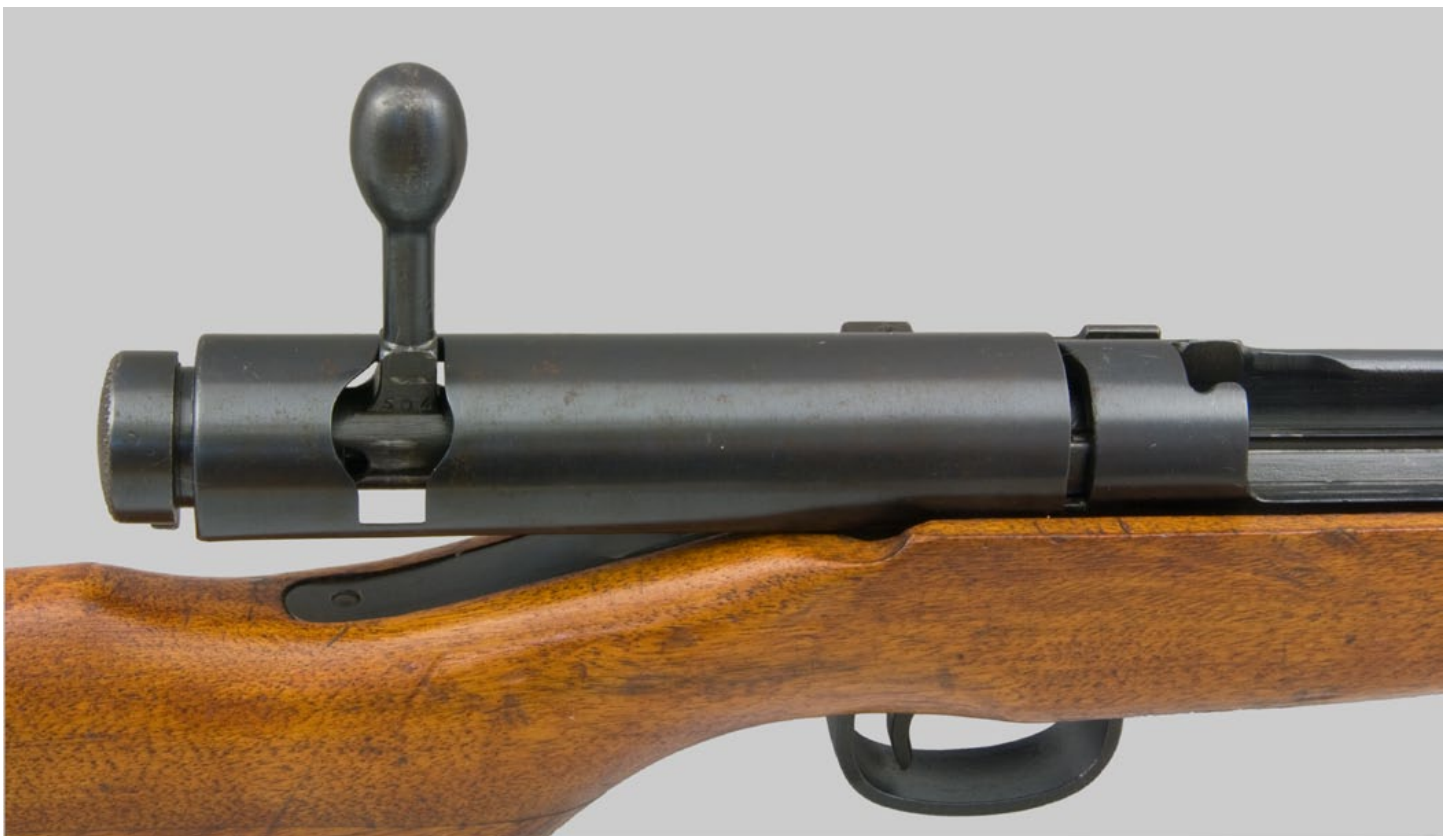
This view illustrates the fine machine work and high-polish blue found on early Type 99s. Even the dustcover is serialized to the rifle. The stock is well-made and nicely finished.

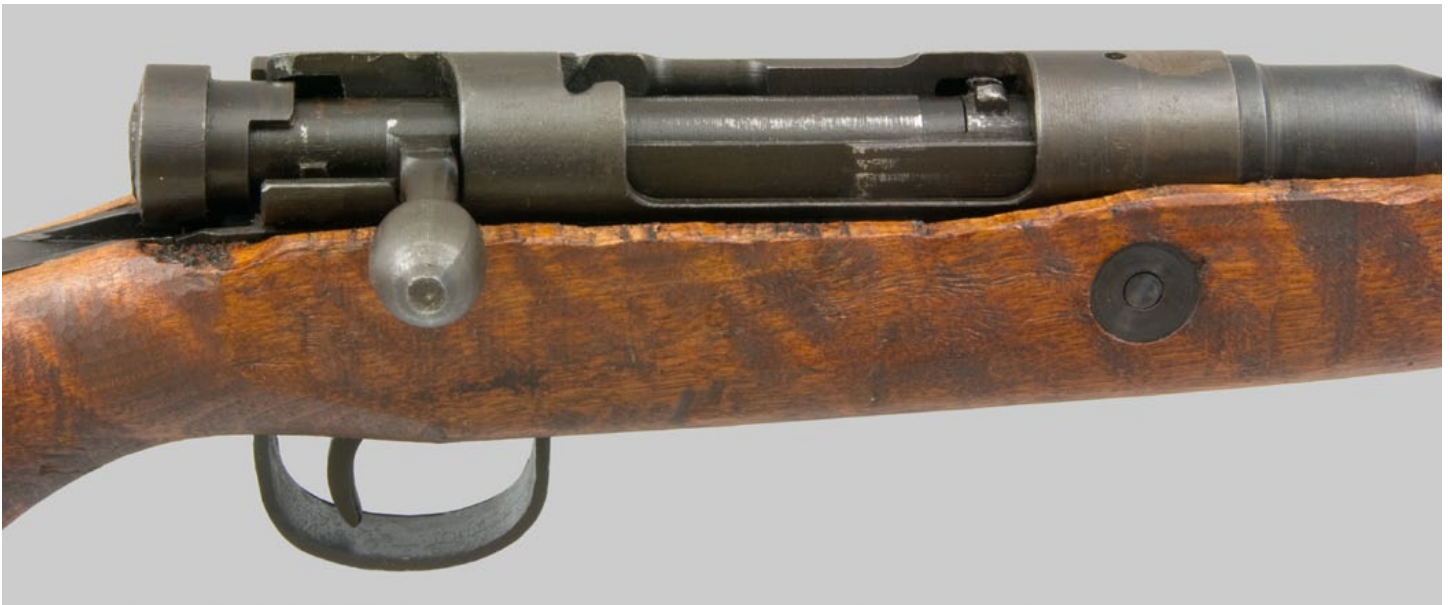
By war's end, little effort is given to metal finishing. The rough tool marks result in a blue that almost looks like Parkerizing. The stock is slender, requiring the use of a large crossbolt reinforcement. The stock is actually made of pretty, tiger-striped wood, but is left very rough.

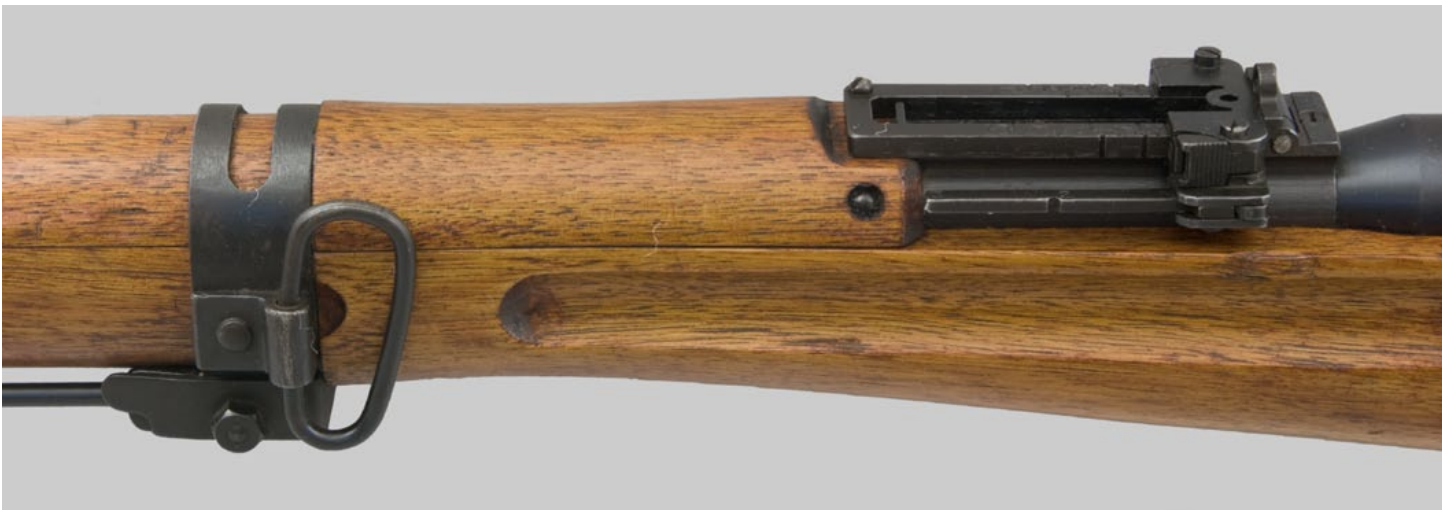
One of the distinctive features of the original Type 99 design is the adjustable rear sight with anti-aircraft wings and lower band with the folding monopod. The stock has nicely-executed finger-grooves and everything fits just right.

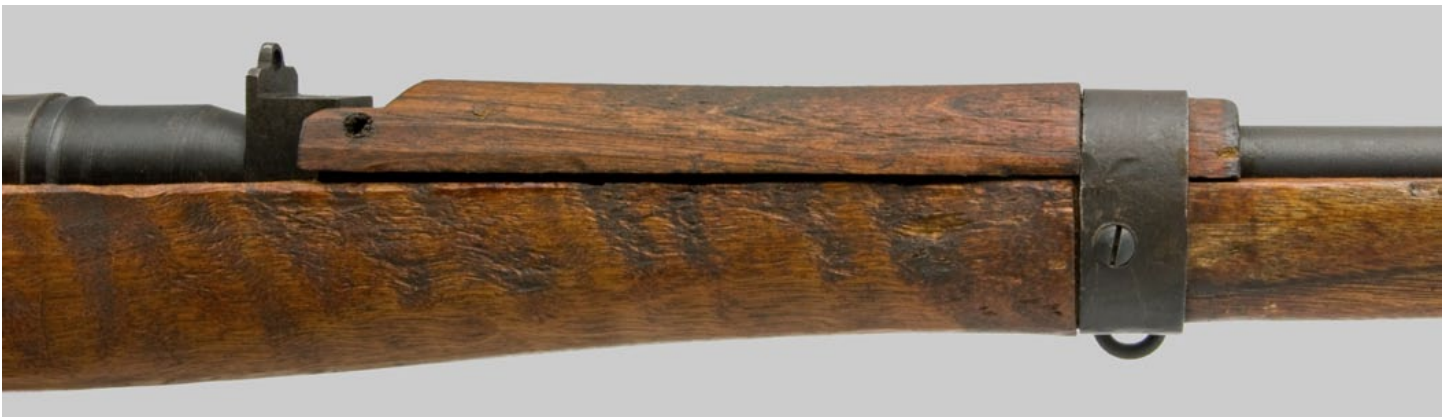
By war's end, the rear sight is a fixed peep, zeroed to 300 meters. The monopod has been deleted. The wood is rough and ill-fitted. The fore stock, from the band forward, is a separate piece of wood. This is often mistaken for a duffle-cut, however, the stock was that way from the factory.

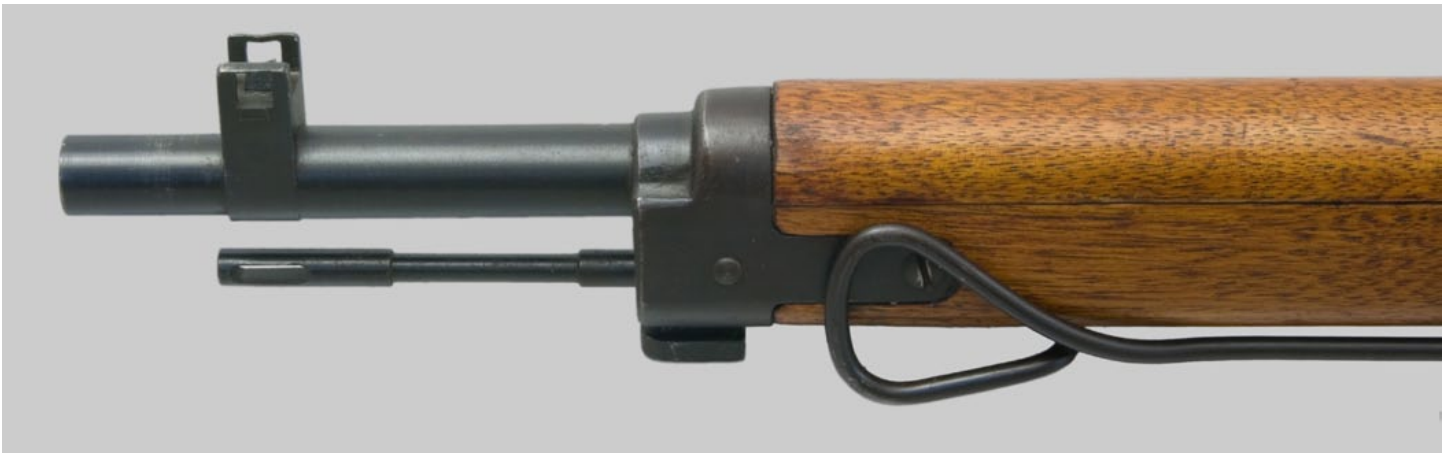
Early rifles had a full-length hand guard and a front sight protector. The nicely-contoured upper band/bayonet lug is secured by three screws. The 22.75-inch long cleaning rod is secured by a push-button catch in the fore stock.

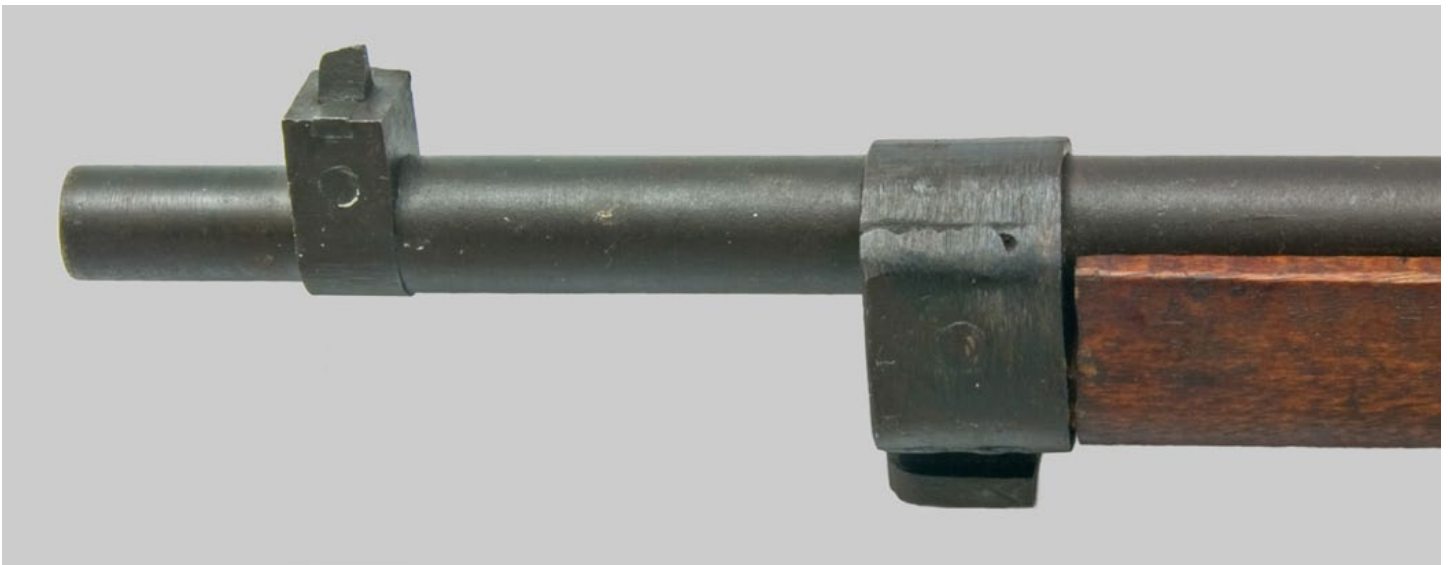
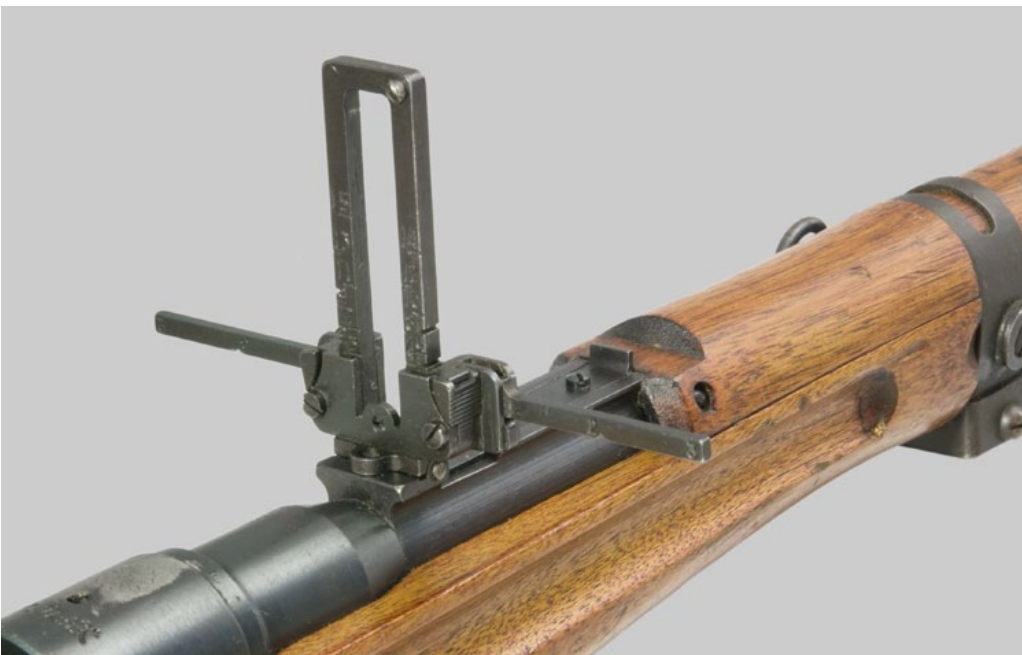
Another view, showing the intricate anti-aircraft sight and the nice fit and finish of the early rifles.
